EAST WEST GATEWAY COUNCIL OF GOVERNMENTS

# METROLINK SYSTEM-WIDE SECURITY ASSESSMENT

## EXISTING CONDITIONS REPORT

### FINAL REPORT

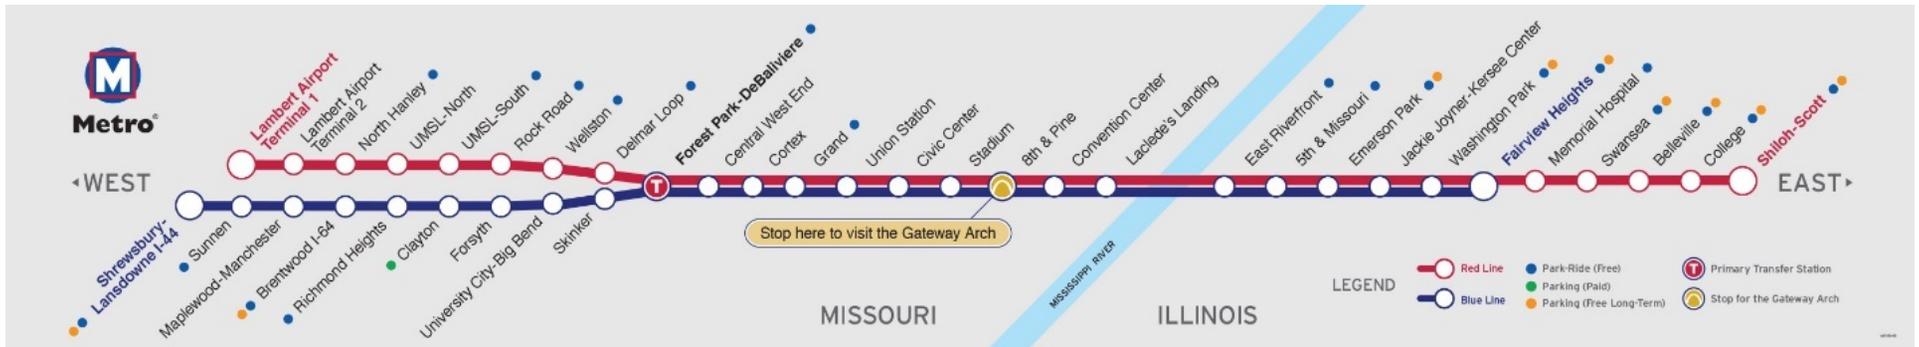
Figure 1. MetroLink System Map

The St. Louis MetroLink system consists of 46 line miles with 38 stations across two lines that generally run east-west. Thirteen stations are exclusive to the Red Line, 9 stations are exclusive to the Blue Line, and the remaining 16 stations service both lines, as shown on the system map in Figure 1.

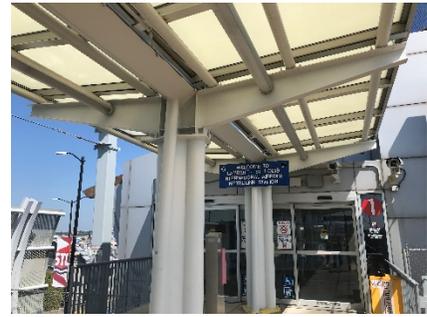
## LAMBERT TERMINAL 1 ●

- Elevated center platform station
- Six CCTV cameras on platform, three at each end providing views of both sides of platform
- Seating areas and ad panels block sight lines on platform
- Escalator and elevator at west end of platform provides direct access to airport terminal
- Escalator out-of-service during several visits

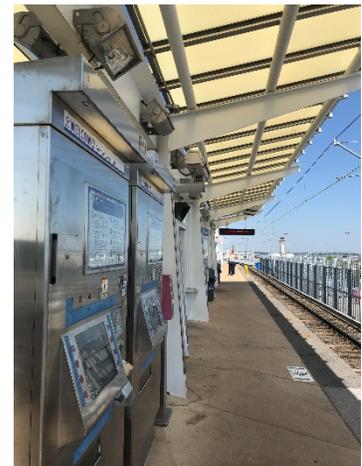
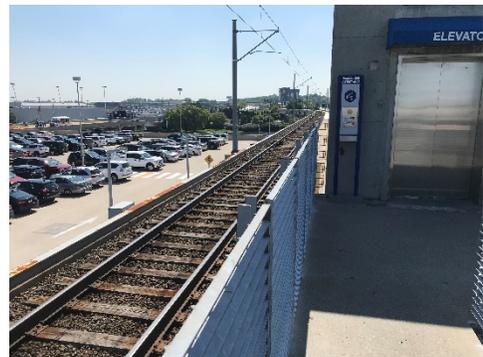
## LAMBERT TERMINAL 2 ●

- Elevated center platform station
- Four CCTV cameras total at station: three at east end of platform with one aimed directly at elevator door and two aimed at the platform, and one camera located at west end of platform looking east
- No cameras are aimed at TVMs or validators
- Elevator located at west end of platform provides access to parking lot below
- No direct access from terminal to platform, but well-marked pedestrian path from bottom of platform through parking garage to terminal
- Pathway through parking garage is marked with paint only; no physical barrier separates pedestrians from parked cars
- Seating areas and ad panels block sight lines on platform
- Escalator and elevator at west end of platform provide access to airport terminal

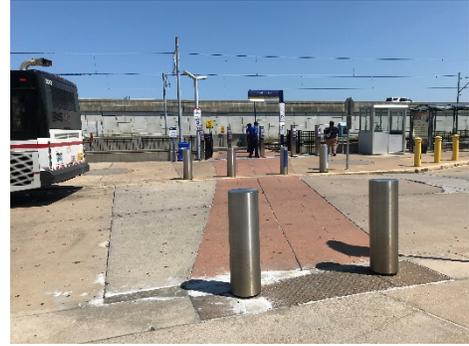
## NORTH HANLEY ●

- At grade side platform station
- CCTV cameras at each end of platform
- Large park and ride facility with garage and seven bus bays
- Glass staircase to parking garage provides eyes on the street and open views
- Food link truck at site, when open, enhances natural surveillance by adding “eyes on the street” from staff and customers
- Five fare validators at entry to platform

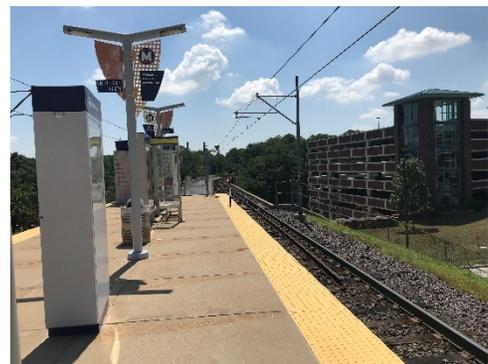
## UMSL NORTH ●

- Below grade station with side platform
- CCTV cameras at each end of platform
- One dome CCTV camera at entry to platform
- Large park and ride lot and bus transfer facility
- Serves UMSL campus
- Parking lot is above the platform but area is open with good sight lines from parking lot into platform

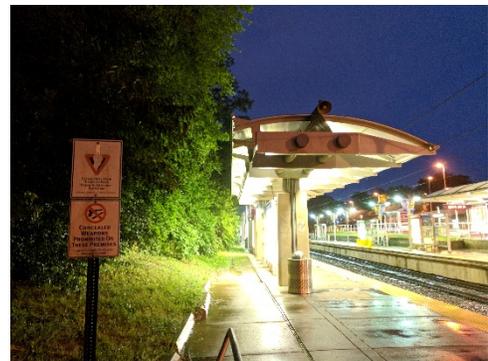
## UMSL SOUTH ●

- At grade station with side platforms
- Park and ride lot and bus transfer facility
- CCTV cameras at each end of platform
- Public art located at parking and ride lot
- Thick vegetation behind east bound side platform

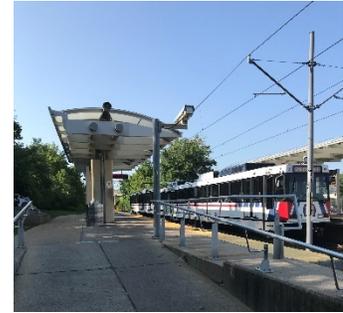
## ROCK ROAD ●

- At grade side platform station
- Large park and ride and bus transfer center
- Poor maintenance, as indicated by pot holes in concrete on platforms, base plate for lighting pole loose and light pole removed, ad panels fogged over
- Blind spots on bus side created by shelters
- Two CCTV cameras located at each end of platform, plus a dome camera located at TVM building
- Night time lighting is dim
- Good sight lines from platform to parking and bus areas, and platform entry area

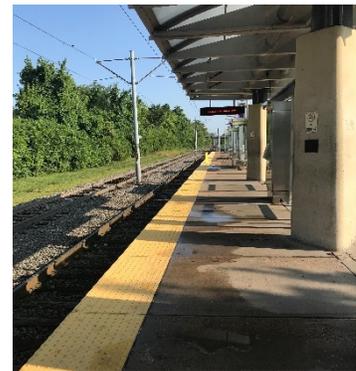
## WELLSTON ●

- At grade station with offset platforms on either side of intersection with Plymouth Road
- Park and ride lot located on east bound side of station
- One CCTV camera at each platform
- TVM machines located on westbound side with park and ride lot
- Well-marked fare zone; however, passengers were observed waiting just outside of fare zone and until train pulled up to enter fare zone and board the train

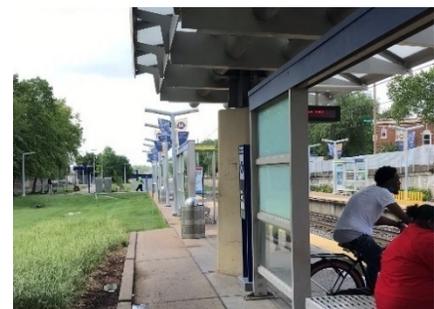
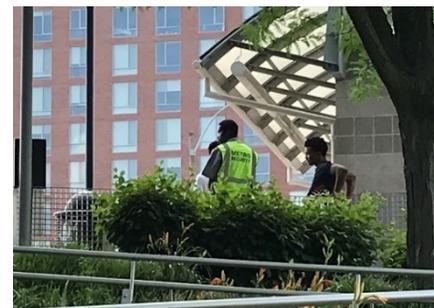
## DELMAR LOOP ●

- Below grade open cut type station with side platforms
- Park and ride lot with separate access to platforms from the east accesses the station as an at-grade platform
- Bus transfer point at street level above
- Security/staff booth at street level with view of platform area and bus transfer area
- Ramps provide access to platforms from street level
- Well landscaped and maintained
- Lack of signage at platform level directing passengers to park and ride area
- Observed people congregating at top of stairs at street level creating a 'gauntlet' for passengers to pass through on their way to buses, parking areas, etc.

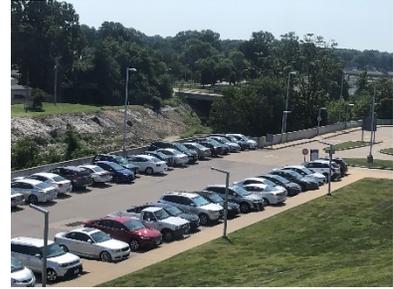
### SHREWSBURY-LANSDOWNE I-44 ●

- Elevated center platform station
- End of line for Blue Line trains
- Large park and ride lot near I-44
- CCTV cameras located at ends of platform

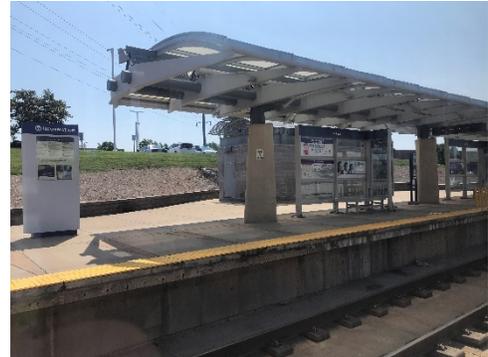
### SUNNEN ●

- At grade station with side platforms
- Large park and ride lot with bus connections
- Office park nearby
- CCTV cameras at end of platforms
- TVM building blocks sight lines and creates blind spots behind building

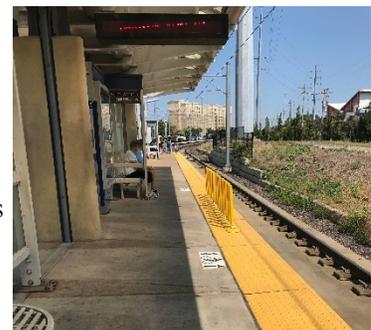
### RICHMOND HEIGHTS ●

- At grade center platform station
- CCTV cameras located at ends of platform
- Serves nearby mall as well as park and ride
- “Fare corral” defines fare zone and forces passengers to face tracks when crossing them to access platform ramp

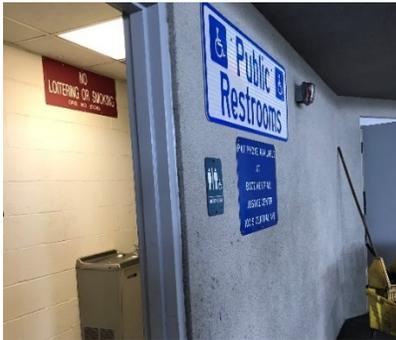
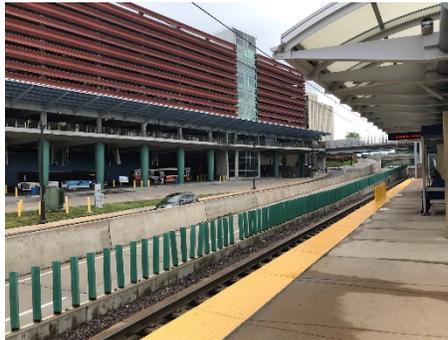
## CLAYTON

- Center platform situated in the median of Forest Park Parkway
- At grade platform along parkway with elevated crossings over parkway for passenger access to Clayton
- Adjacent to parking garage and bus transfer station
- Dead-end platform with single-end access.
- Well-defined station area typical MetroLink amenities and furnishings
- Clearly-marked fare zone area
- Public restrooms available at adjacent bus transfer facility and situated in a way that does not allow for good natural surveillance

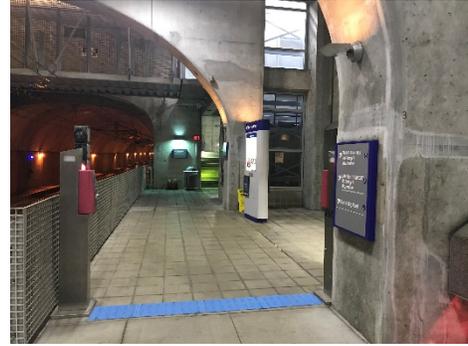
### UNIVERSITY CITY-BIG BEND ●

- Underground station with side platforms
- Two entrances and two mezzanines facilitate changing platforms
- ADA ramps along entire platform
- Glass corridor along ramps provide view into platform
- Public art exhibited on platforms
- CCTV cameras at each end of platform and in Mezzanine landings
- Good wayfinding to streets above station
- Some blind spots at information kiosks and by TVMs and entry to ramps

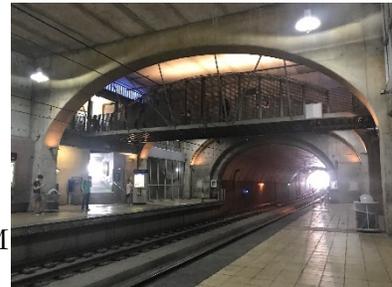
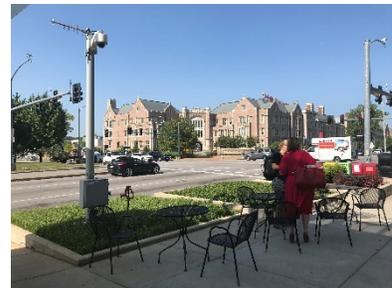
### SKINKER ●

- Underground station with side platforms
- Walkway over tracks allows for ease of changing platforms or crossing to uses on other side of station
- Good wayfinding
- CCTV cameras located at end of each platform as well as in TVM area
- Coffee shop and Washington University located at top of station

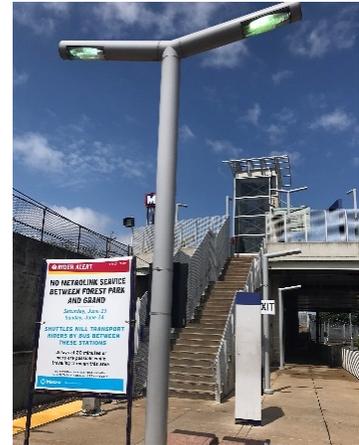
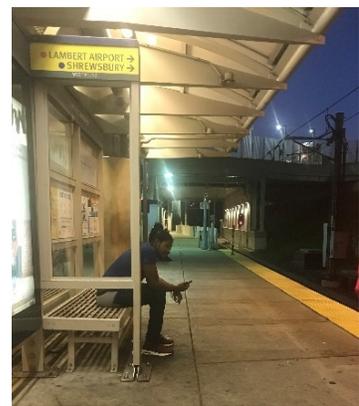
## FOREST PARK-DEBALIVIERE ●●

- Main transfer point to westbound Blue Line trains
- Below grade open cut station with center platform area and stairs to street level above
- Dead-end platform with all entrances from above Debaliviere Avenue overpass

- Passengers questioned the WSP team for taking pictures and called MetroLink customer service rather than talk to Securitas staff

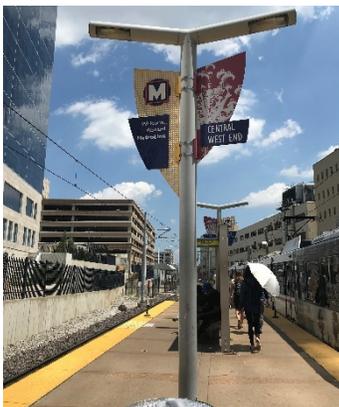
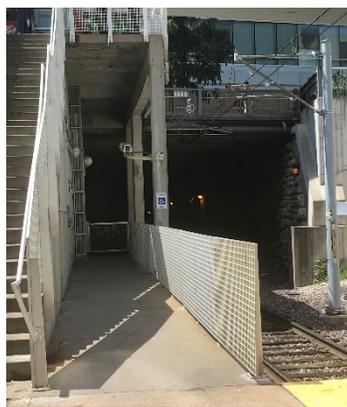
## CENTRAL WEST END ●●

- Located at hospital complex in below grade open cut style platform
- Presence of nearby buildings gave appearance of being seen from above
- One CCTV camera placed on each end of platform
- Elevator located at end of platform under overpass with low visibility and hiding spots
- Dome camera located at end of building adjacent to platform, likely not MetroLink asset
- Off-set pedestrian crossing to platform across tracks, which forces passengers to look down direction of tracks for better visibility of arriving trains

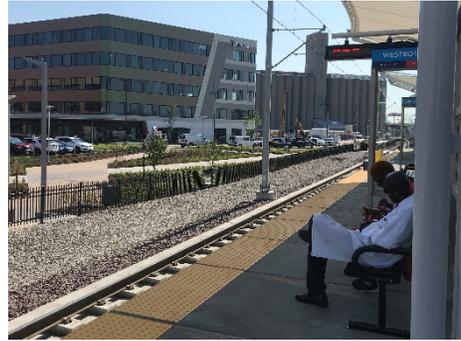
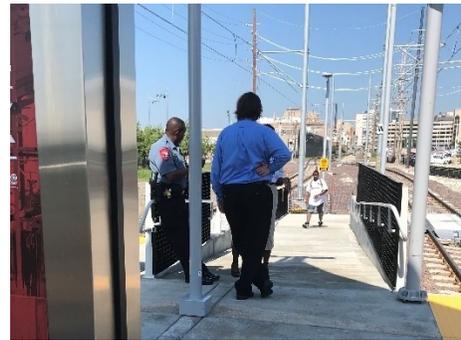
## CORTEX ●●

- Newest station on the system, opened in July 2018
- At grade center platform station
- Fencing is black and somewhat different than typical MetroLink station
- Electronic message sign with schedule information creates potential hiding spot by blocking sight lines on platform
- Bicycle racks located by staff booth
- Dome style CCTV cameras at each end of platform
- Exposed conduit that could pose security vulnerability
- Emergency phone with blue light located at center of platform
- Direct pedestrian connections to adjacent office park

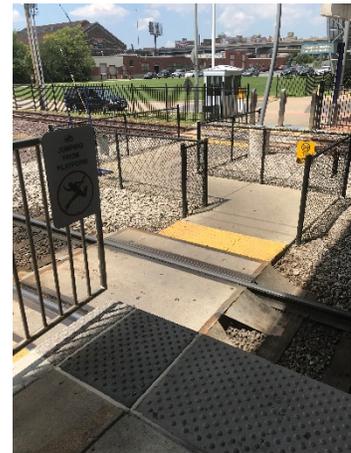
## GRAND ●●

- Station located under S. Grand Boulevard overpass
- Bus transfer above train platform on overpass
- Two sets of stairs and elevators provide access to either side of S. Grand Boulevard
- Diverted pedestrian crossing provides access to platform
- Emergency phone located on bus side across from platform
- Passenger waiting area and TVMs located underneath overpass, separated by access road/drop off area
- CCTV cameras located at ends of platform

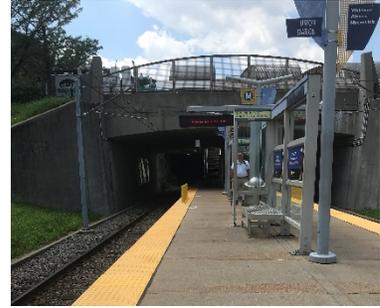
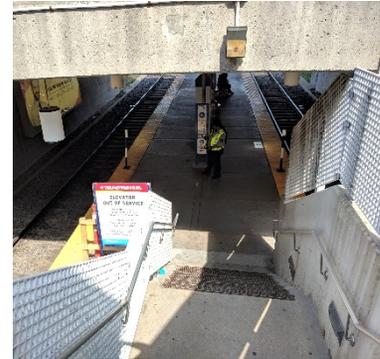
## UNION STATION ●●

- Below grade open cut type station with center platforms
- Entry at both ends of platform
- CCTV cameras at ends of platform
- Elevator located at overpass
- Offset pedestrian crossing located at east end of platform
- Bus transfer area located above on 18th street
- Below grade configuration limits good sight lines from street and surrounding uses

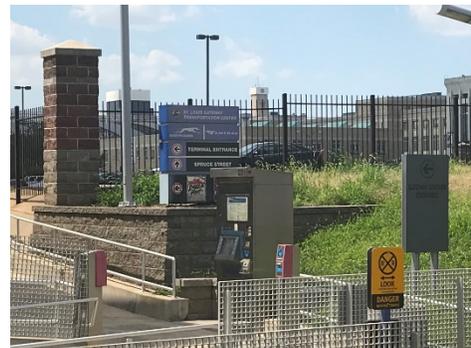
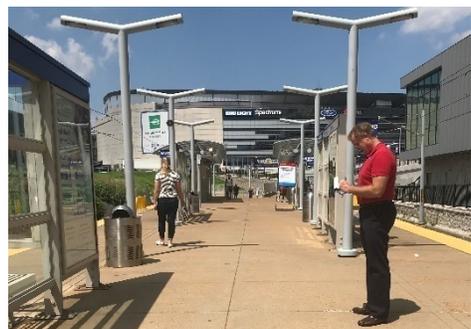
## CIVIC CENTER ●●

- Below grade open cut style station with wide center platform
- Multimodal stop with access to Amtrak and bus station, as well as direct access to Enterprise Center
- Serves downtown St. Louis and the Blues NHL (Enterprise Center)
- CCTV cameras are dome style, one at each end of platform and a third located in the middle of the platform aiming west
- West end of platform accesses both sides of the station, while east end only crosses to the north side of the station
- Accessible ramps connect station to surrounding uses
- Modern style emergency/information call boxes with blue lights on top, one at each end of platform
- Off-set pedestrian crossing to platform across tracks, which forces passengers to look down direction of tracks for better visibility of arriving trains
- Good wayfinding to station and surrounding uses and transportation connections

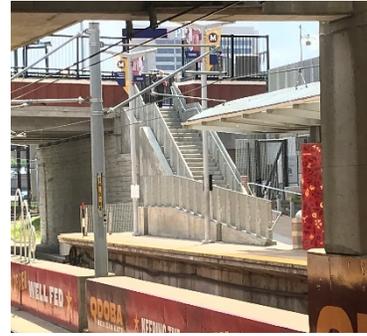
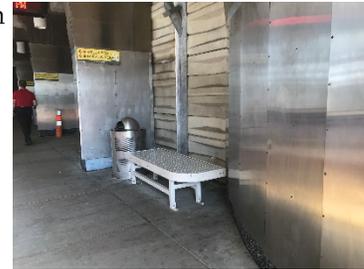
## STADIUM ●●

- Below grade open cut type station with side platforms
- Hiding areas created by arcing seating walls located on eastbound platforms
- Station has advertising and wraps on walls and columns that are not consistent with the rest of MetroLink stations
- CCTV cameras located at each end of platform
- Long ADA walkways provide access to sidewalks/roadway above
- Serves downtown St. Louis and the Cardinals MLB Ballpark (Busch Stadium)

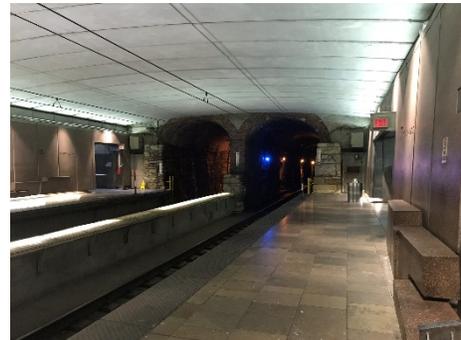
## 8TH & PINE ●●

- Underground station with side platforms.
- Built in seating areas.
- 4 different entrances result in confusing wayfinding
- Station name is difficult to see from inside rail cars
- Lighting could be improved as it is fairly dim on the platforms
- CCTV cameras visible, one at each end of platform and cameras in main entryway on either side of platform at TVM area
- Well-marked ticket validators and fare zone boundary
- Platform area feels somewhat isolated and TVMs were in main landing area but off to side, creating hiding spots and ambush points

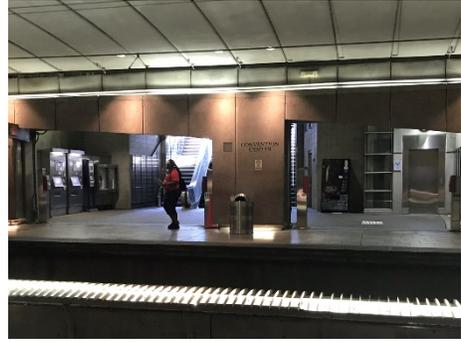
## CONVENTION CENTER ●●

- Underground station
- Four total entrances, two secondary on each side and two main entryways with TVMs, passenger information, elevator, and escalator
- Side platforms
- CCTV cameras at each TVM area and one each at platform ends
- Lighting needs improvement, feels dark/dim at platforms
- Poor sight lines in TVM area and monument signs can create hiding spots/ambush points
- Confusing wayfinding that is made more complicated by the multiple entrances
- Difficult to see station name from inside train

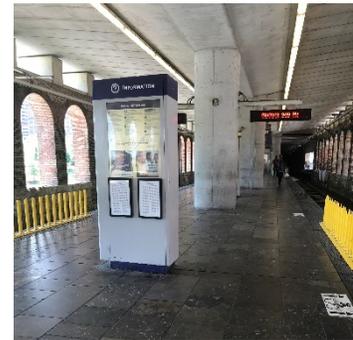
## LACLEDE'S LANDING ●●

- Elevated station located in historic train bridge underneath roadway deck of Eads Bridge
- Wide center platform with views of Gateway Arch and grounds
- CCTV cameras located at each end of platform
- Public art banners hanging from ceiling of platform

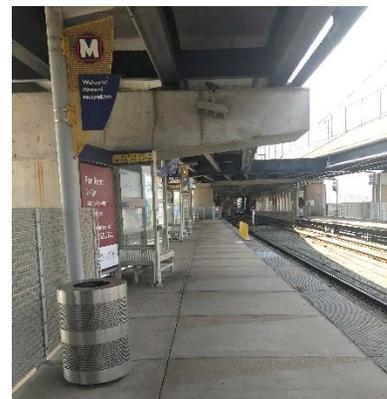
## EAST RIVERFRONT ●●

- Elevated side platform station on east side of Mississippi River
- Major land use served is a casino
- Two elevators on platform provide access to uses below
- CCTV cameras located at each end of station and one dome camera located at West end of platform
- Somewhat isolated due to lack of sight lines into the station from below

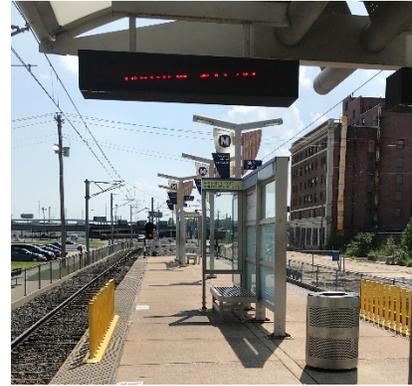
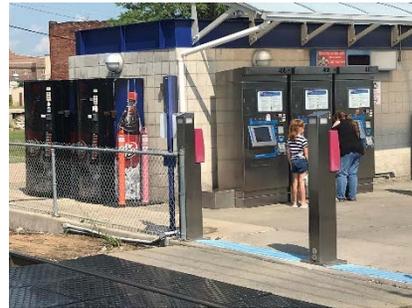
## 5TH & MISSOURI ●●

- A single dome camera at each end of platform
- Center platforms are at grade
- Adjacent to a park and ride lot
- Ticket Vending Machines (TVMs) are visible from the platform and parking lot
- Vending machines are around the side of the TVM building and only visible from the platform, creating a potential ambush point
- Platform was clean and open allowing for natural surveillance from the parking lot and the platform itself
- Digital message signs and audio announcements were working and provided arrival information

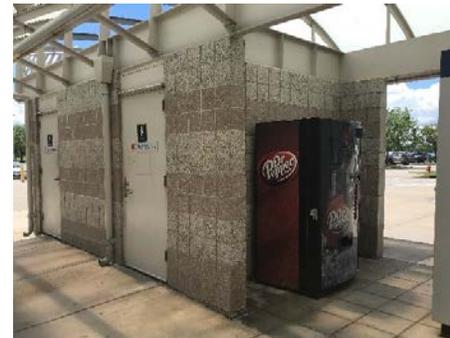
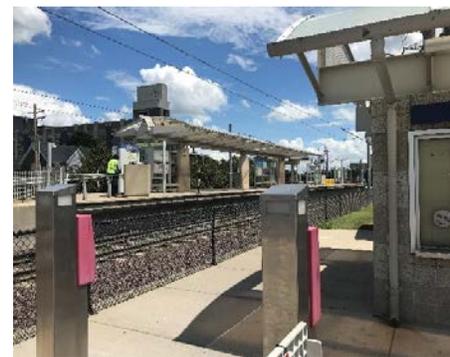
## EMERSON PARK ●●

- At grade station with center platform
- Large park and ride lot with bus transfer facility
- Direct connection to residential neighborhood across from platform
- Commercial building available for lease to serve passengers; however, this does not appear to be in use
- One end of building closest to platform appears to be for MetroLink security staff, though no personnel could be seen from outside due to reflective film on the storefront and the space was located behind TVM building that had limited view of parking and bus transfer area
- Diverted pedestrian crossing at tracks to access platform
- Pedestrian bridge connects station to residential neighborhood on other side of I-64
- Well branded facility and clear transition zone from parking lot/bus bays to train platform
- TVM building has hiding spots/ambush points where vending machines were located
- Ticket windows were not manned

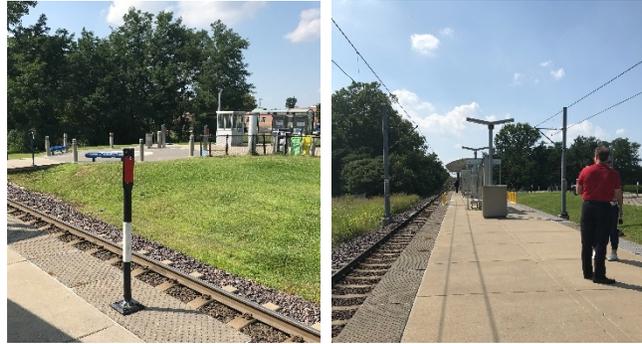
### JACKIE JOYNER-KERSEE (JJK) CENTER ●●

- At grade station serving athletic complex
- Center platform with bus transfer area
- Dead-end platform
- Separate TVM building at bus transfer area
- CCTV cameras at each end of platform
- Well maintained facility with clearly defined boundaries

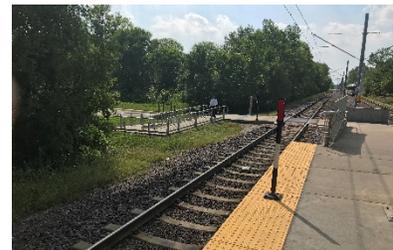
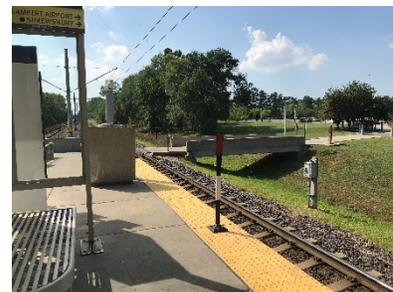
### WASHINGTON PARK ●●

- At grade center platform station
- Large park and ride commuter lot located on west bound side
- Dead-end platform
- CCTV cameras located at each end of platform
- Marked pedestrian crossing at tracks connecting to park and ride as well as adjacent neighborhood on east bound side

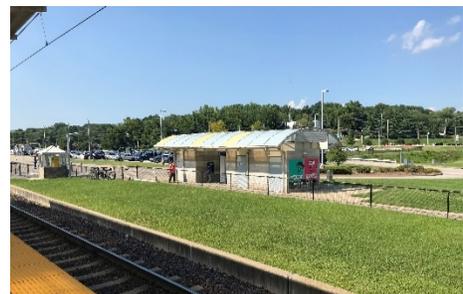
### FAIRVIEW HEIGHTS ●●

- At grade station with center platform
- Last Blue Line station; trains continuing east are Red Line
- TVM building has employee-only restrooms
- Building blocks sight lines, creating hiding/ambush points
- Well maintained, well defined station

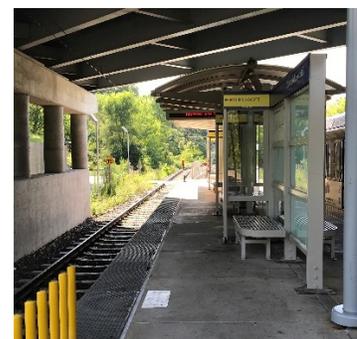
### MEMORIAL HOSPITAL ●

- Below grade station with center platform.
- Park and ride lot above station area connected with ADA ramps
- TVM building with two TVMs
- Broken glass panel at one shelter
- Direct connection to Metro Bike Link Trail

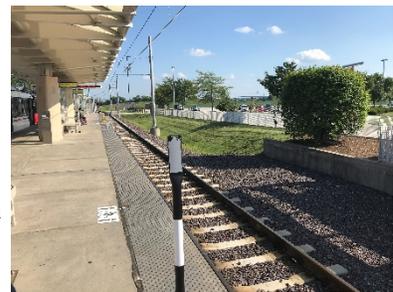
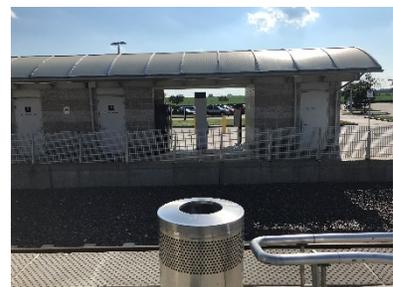
## SHILOH-SCOTT ●

- End of line for Red Line trains on Illinois side
- At grade center platform
- CCTV cameras at each end of platform
- Serves Scott Air Force Base and has a secure entry to the base on eastbound side
- Park and ride lot and bus transfer facility on westbound side
- Open platform with good views throughout parking areas and station

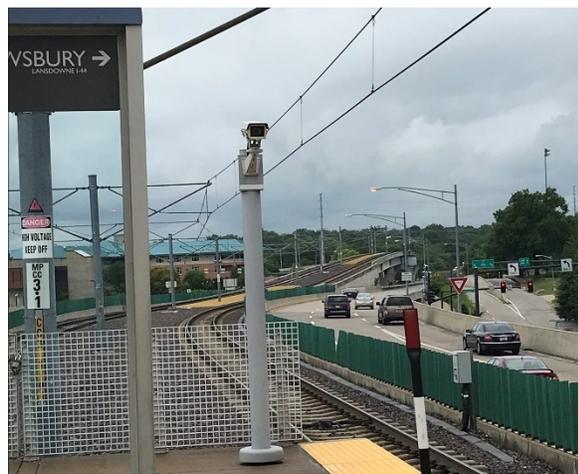
Figure 2. CCTV Camera on Clayton Platform

The platform cameras were originally installed for crowd control, so most are low-resolution and fixed view. This arrangement is consistent with camera deployment for liability investigations, rather than security of the system. Most deployment of camera for security reasons include pan-tilt-zoom (PTZ) cameras that can provide an enhanced view of the platform or system, along with the ability to move or pan the area for wider coverage. As funding becomes available, Metro will replace the cameras with high-resolution cameras with facial recognition technology. MetroLink's video network infrastructure/configuration needs improvement. The existing ViconNet video management system (VMS) software is serviceable but obsolete and experiences memory leaks and software bugs that have not been upgraded due to cost. VMS receives video analytic alarms from AGENT VI services and displays intrusion incidents as configured. In addition, the DVRs on vehicles are beyond their repair life; a capital funding request has been made to upgrade the system.

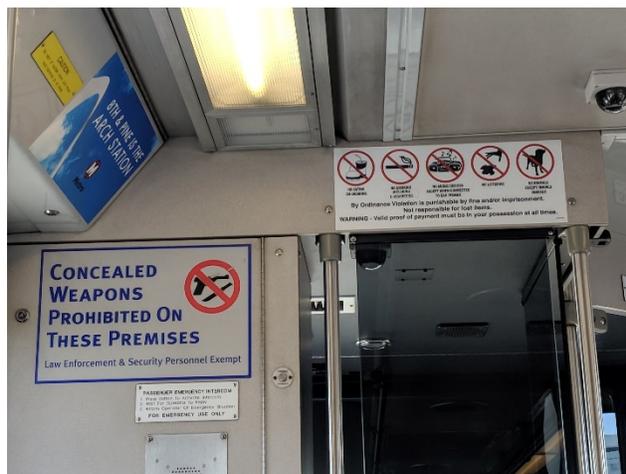
Figure 3. CCTV Cameras on Vehicle

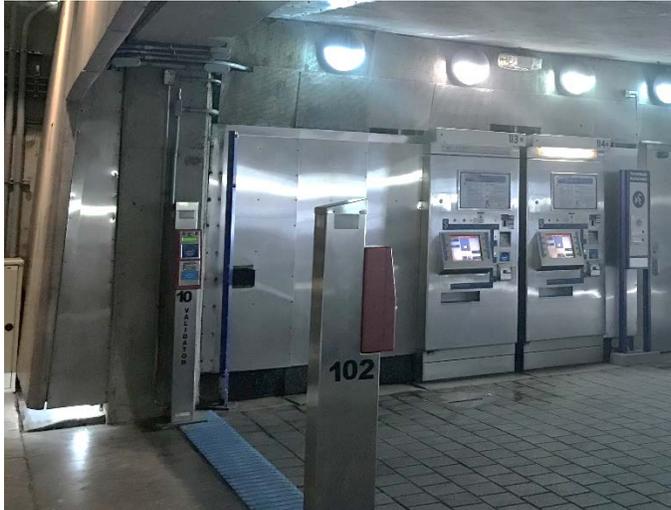
**Figure 4. MetroLink TVMs, Validators, and Fare Zone**

TVMs and ticket validators are available at all 38 MetroLink stations and at most Metro Transit Centers. All TVMs accept \$1-, \$5-, \$10-, and \$20-dollar bills for any transaction, as well as Visa, MasterCard, and Discover credit cards. Metro tickets may also be purchased online at MetroStore.org or in person at the MetroStore in downtown St. Louis near the 8<sup>th</sup> & Pine MetroLink station. Various retail vendors throughout the metropolitan area (e.g., Schnucks Markets) sell Metro fares. Tickets cannot be purchased or validated on the trains themselves.

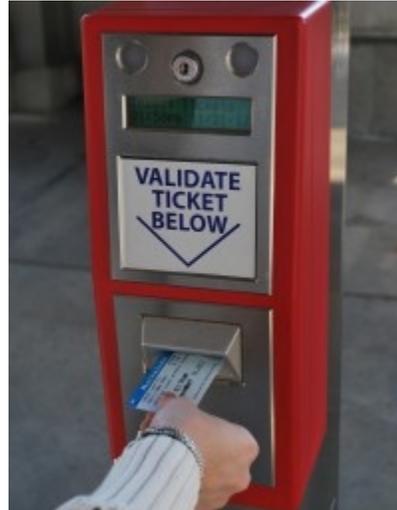
**Figure 5. Ticket Validation**
